DEPARTMENT OF TRANSPORTATION

Contract #: 04-0120F4Cty: SF/ALA Rte: 80 PM: 13.2/13.9File #: 13.28**WELDING INSPECTION REPORT****Resident Engineer:**Pursell, Gary**Address:** 333 Burma Road**City:** Oakland, CA 94607**Report No:** WIR-005837**Date Inspected:** 24-Mar-2009**Project Name:** SAS Superstructure**OSM Arrival Time:** 630**Prime Contractor:** American Bridge/Fluor Enterprises, a JV**OSM Departure Time:** 1600**Contractor:** Oregon Iron Works Clackamas, Or.**Location:** Clackamas, Oregon**CWI Name:** See below**CWI Present:** Yes No**Inspected CWI report:** Yes No N/A**Rod Oven in Use:** Yes No N/A**Electrode to specification:** Yes No N/A**Weld Procedures Followed:** Yes No N/A**Qualified Welders:** Yes No N/A**Verified Joint Fit-up:** Yes No N/A**Approved Drawings:** Yes No N/A**Approved WPS:** Yes No N/A**Delayed / Cancelled:** Yes No N/A**Bridge No:** 34-0006**Component:** Hinge K Pipe Beams**Summary of Items Observed:**

WELDING INSPECTION REPORT

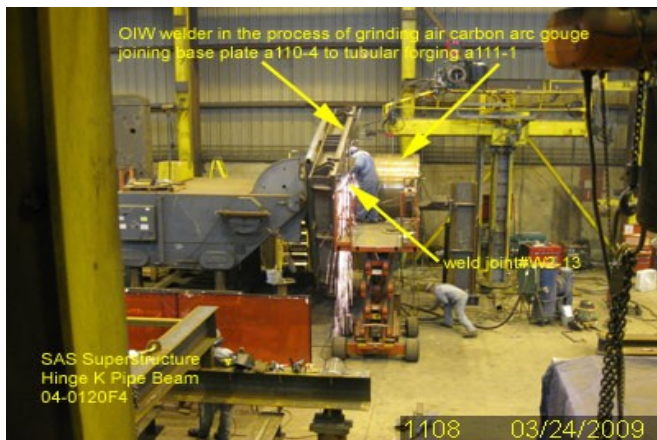
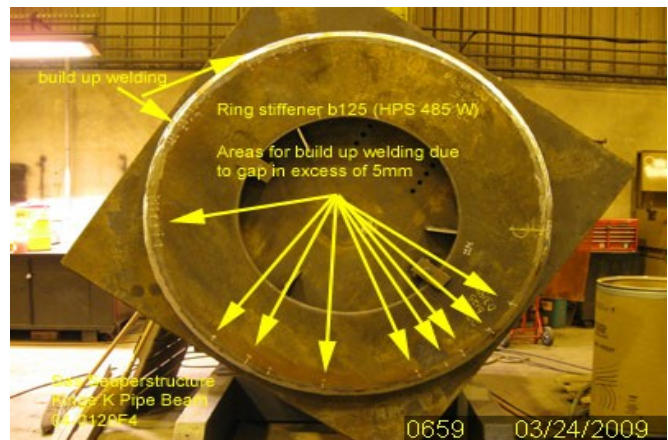
QA Inspector Brannon randomly observed OIW qualified welder Mr. Rick Hinkle ID#H49 tack welding joining half fuse section MK#a124-7 (HPS485 W) to half fuse section MK#a124-6 (HPS485 W). The complete joint penetration (CJP) weld is identified as weld joint #WM3-18. Mr. Hinkle was observed welding in the 1G (flat) and 3G (vertical) positions utilizing flux corded arc welding (FCAW) process with a .045 inch (1.2mm) diameter electrode, filler metal brand Hobart Fabco 91K2-C class 91T1-K2J semi-automatic. The above .045 inch (1.2mm) diameter electrode was verbally approved to use for tack welding on 03-18-2009.

QA Inspector Brannon randomly observed OIW qualified welder Mr. Craig Jacobson ID#J6 welding a joining hinge K pipe beam MK#a111-1 (A508 Gr. 4N Class 2) to base plate MK#a110-4(HPS 485 W) to. The complete joint penetration (CJP) weld is identified as weld joint #W2-13. Mr. Jacobson was observed welding in the 1G (flat) position utilizing submerged arc welding (SAW) process with a 2.4mm diameter electrode, filler metal brand Lincoln Electric LA85 class F9A4-Eni5-G-H2. QA Inspector Brannon observed the OIW QC CWI Inspector's Mr. Mike Gregson and Mr. Rob Walters verifying that the pre-heat and welding parameters were in accordance with the Welding Procedure Specification (WPS). Welding parameters measured by QA are as follows: 600 amps, 33.0 volts and a travel speed of 457.0 mm/min. Welding parameters observed/measured by QA Inspector Brannon appear to be in general compliance with the approved WPS 4016 revision number 0.

QA Inspector Brannon observed OIW preheating and build up welding approximately 3302mm. QA Inspector Brannon randomly observed OIW qualified welder Mr. Tim O'Brien ID#O6 and one helper butter welding ring stiffener plate MK#b125 (HPS 485 W) HT#D3147-7B. Mr. O'Brien was observed welding in the 1G (flat) position utilizing flux cored arc welding (FCAW) process with a 1.3mm diameter electrode, filler metal brand Select Arc 920-NiI class E91T1-NiI-C-H4 semi-automatic. QA Inspector Brannon observed the OIW QC CWI Inspector Mr. Rob Walters verifying that the pre-heat and welding parameters were in accordance with the Welding Procedure Specification (WPS). Welding parameters measured by QA are as follows: 260 amps, 26.0 volts and a travel speed of 482.6 mm/min. Welding parameters observed/measured by QA Inspector Brannon appear to be in general compliance with the verbally approved WPS 3049 revision number 0. QC Inspector Mr. Mike Gregson stated that OIW will submit a welding repair report (WRR-2244-10). Note: WPS 3049 was verbal approved for use in build up welding on 03-20-2009.

The following digital photograph below illustrates observation of the activities being performed.
